Service Manual

8065752478 Rev. B, CATALOG NO.
906-2150-001 Rev. B, TEXT ONLY

***Centurion** Vision System Service Manual**
8065752478

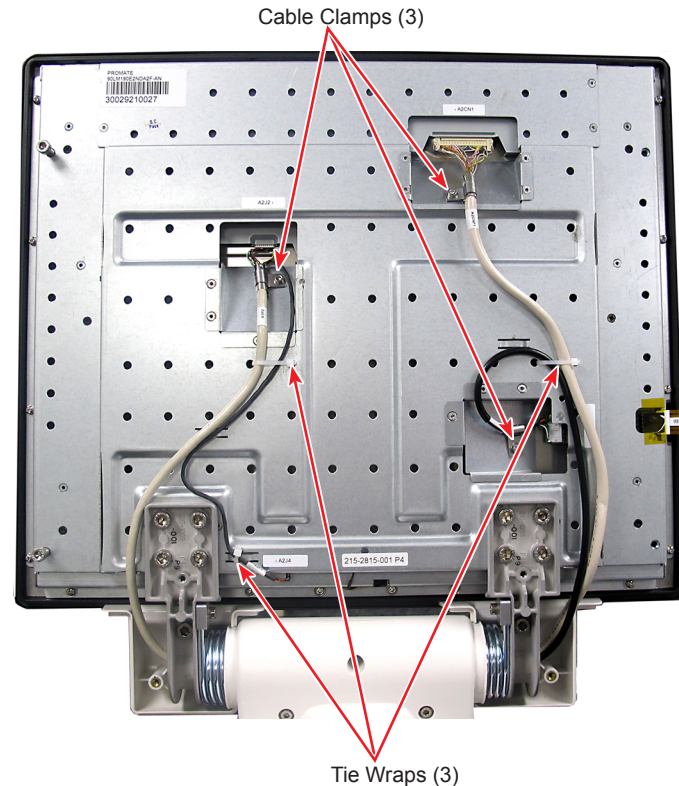
Figure 3-34 Display Cable Routing

- 35.1 Remove Display Wrap Handle and Display Bucket.
- 35.2 Cut three tie wraps securing cables W104-CNP1, W103-P2 and P4, and W126-P1 to Display Assembly (see Figure 3-34).

REPLACEMENT: Note cable routing as shown in Figure 3-34.

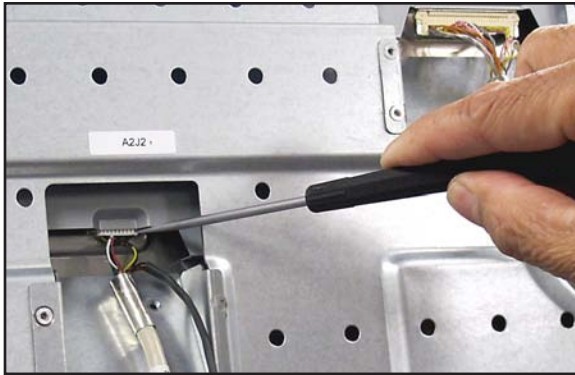
Figure 3-35 Display Connector Removal

- 35.3 Remove three 2.5 mm hex screws securing cable clamps to Display Assembly.
- 35.4 Carefully disconnect CNP1 (squeeze latch on each side to release), P2, P4, and P1 from Display Assembly. **NOTE: A thin blade screwdriver will aid in loosening connector as shown in Figure 3-35.**

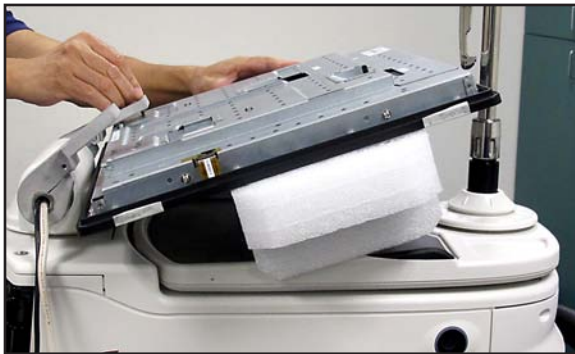
Figure 3-36 Display Supported by Foam Packaging

- 35.5 Place Display in the stored position with a piece of the foam packaging from new Display under the old Display as shown in *Figure 3-36*.

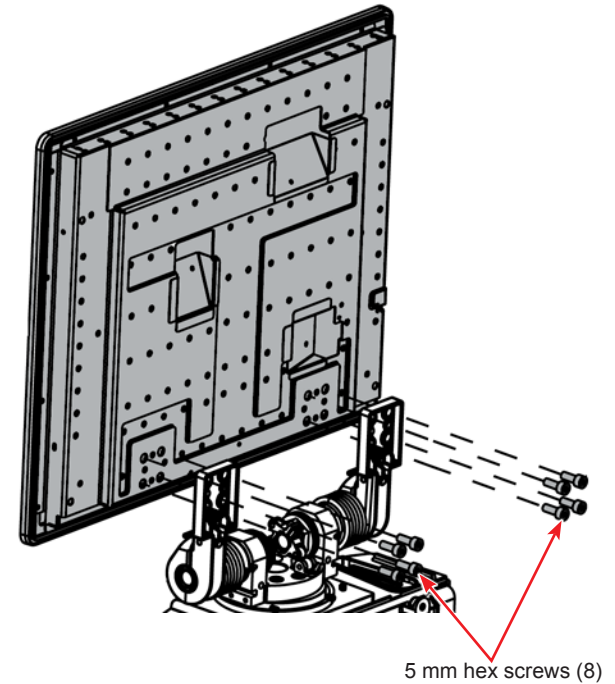
Figure 3-37 Display Removal

- 35.6 Remove eight 5 mm hex screws securing Display Assembly to console (see *Figure 3-37*). **NOTE: Hinge covers will come off when display is removed.**

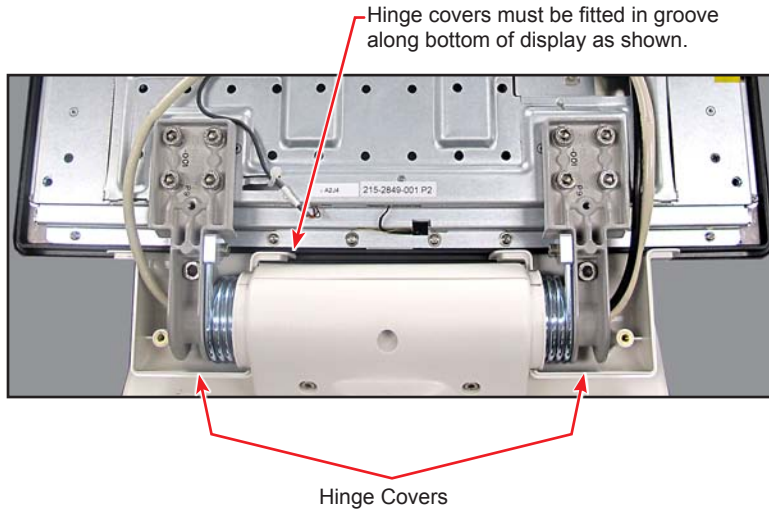
Figure 3-38 Display Hinge Cover Placement

- Install eight 5 mm screws but do not tighten until hinge covers are in position as shown in *Figure 3-38*.
- Alternately tighten eight 5 mm screws securing Display to hinge.

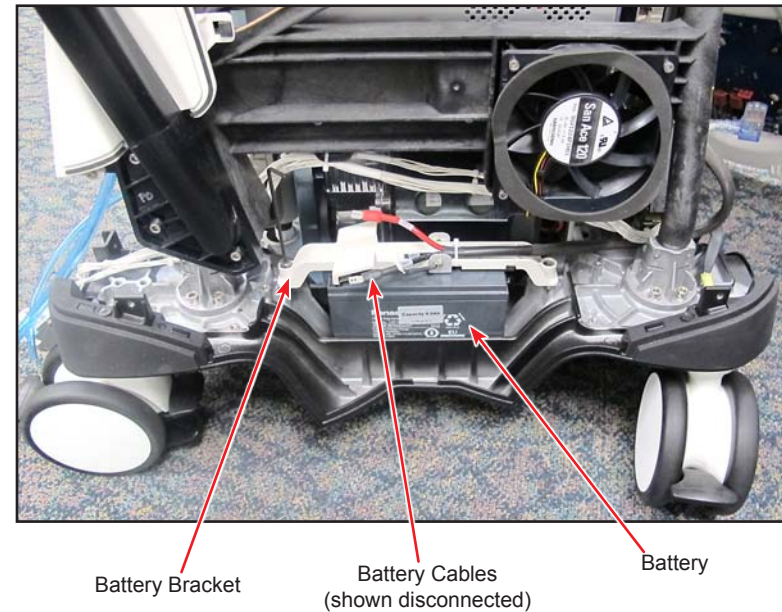
Figure 3-39 Battery Removal

- 36.1 Remove Upper and Lower Rear Panels.
- 36.2 Remove Front Vent, Upper and Lower Front Panels.
- 36.3 Remove Upper and Lower Left Panels.
- 36.4 Remove Upper and Lower Right Panels.
- 36.5 Remove orange 40 A fuse from MFIO PCB.
- 36.6 Disconnect cables from battery (see *Figure 3-39*).

Thermistors are attached to the battery brackets. Use care not to damage thermistors when handling brackets.

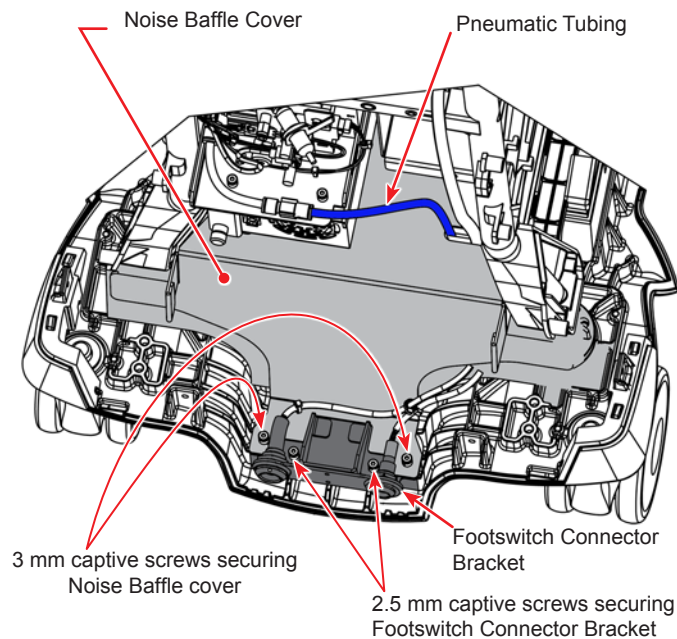
Figure 3-40 Noise Baffle Cover Removal

- 37.1 Remove Upper and Lower Rear Panels.
- 37.2 Remove Front Vent, Upper and Lower Front Panels.
- 37.3 Remove Upper and Lower Left Panels.
- 37.4 Remove Upper and Lower Right Panels.
- 37.5 Remove Front Bumper.
- 37.6 Remove Front Foot Handle Panel.
- 37.7 Disconnect blue pneumatic tubing from Pneumatic Manifold (see *Figure 3-40*).

- 37.8 Loosen two 2.5 mm captive screws securing footswitch connector bracket to chassis.
- 37.9 Loosen two 3 mm captive screws securing Noise Baffle cover to chassis.

- 37.10 Carefully pull Noise Baffle cover from chassis while adjusting tubing and footswitch connector bracket for clearance. Take care not to damage foam insulation attached to the underside of the Noise Baffle cover.
- 37.11 Remove one 2.5 mm hex screw securing Cassette Drain to chassis (see *Figure 3-41*). Reposition Cassette Drain to provide clearance for pump removal.

- 53.1 Remove Front Foot Handle Panel per step 7.
- 53.2 Disconnect blue pneumatic tubing from Pneumatic Manifold (see *Figure 3-40*).
- 53.3 Loosen two 2.5 mm captive screws securing footswitch connector bracket to chassis (see *Figure 3-40*).

- 53.4 Loosen two 3 mm captive screws securing Noise Baffle cover to chassis (see *Figure 3-40*).
- 53.5 Carefully pull Noise Baffle cover from chassis while adjusting tubing and footswitch connector bracket for clearance. Take care not to damage foam insulation attached to underside of the Noise Baffle cover.

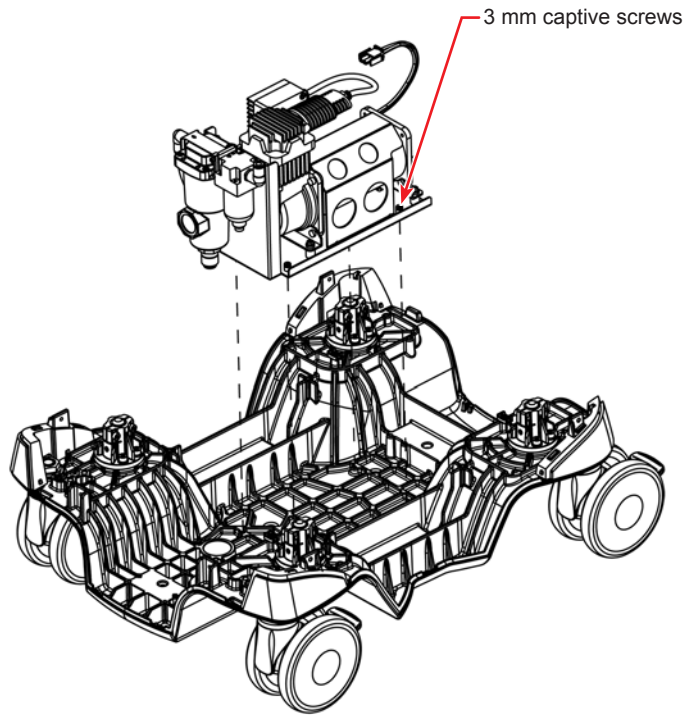
Figure 3-42 **Pneumatic Pump Removal**

- 37.12 Remove both batteries per step 36.
- 37.13 Disconnect Pump Power connection at J4 on MFIO PCB.
- 37.14 Loosen four 3 mm captive screws securing pump to chassis (see *Figure 3-42*).
- 37.15 Reposition pump as necessary and remove from front of console.

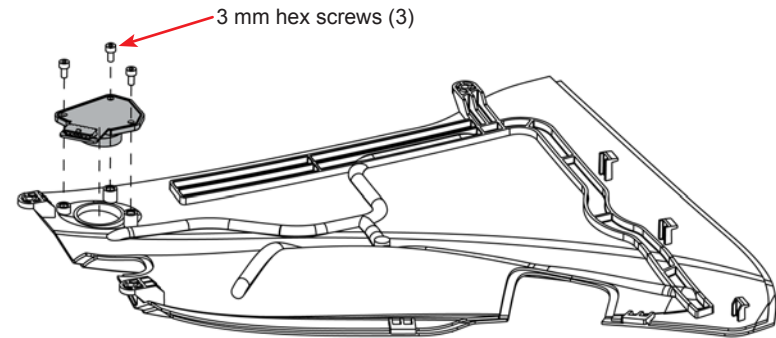
Figure 3-43 **Standby Switch Removal**

- 38.1 Remove Upper Left Panel.
- 38.2 Disconnect J1 from Standby Switch PCB.
- 38.3 Remove three 3 mm hex screws securing PCB to panel (see *Figure 3-43*).

- 38.4 Remove Standby Switch from panel.

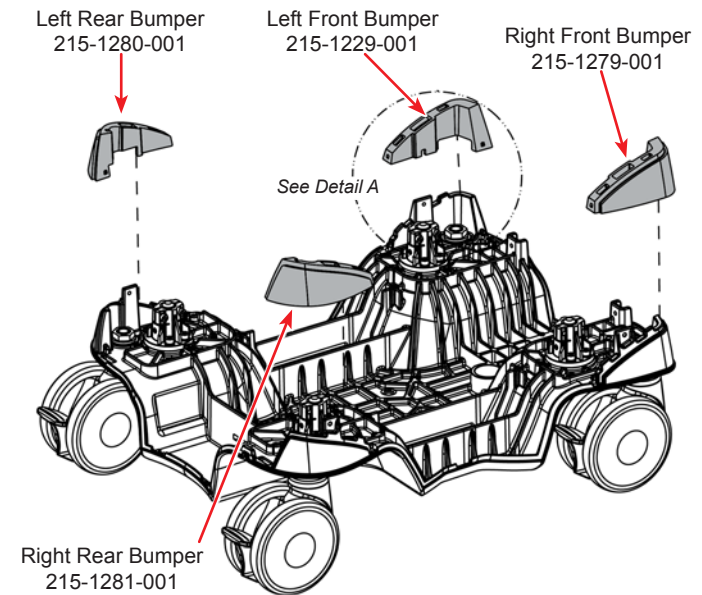
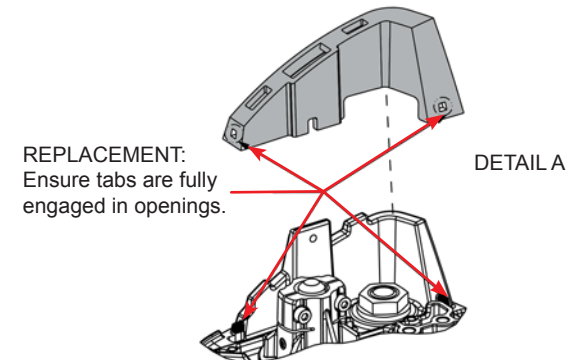
Figure 3-44 Rubber Bumper Removal

- 39.1 Remove panels listed in table below to gain access to bumper to be replaced. Refer to *Figure 3-44* for Bumper location.

- 39.2 Pull bumper off tab at each side and remove from chassis.

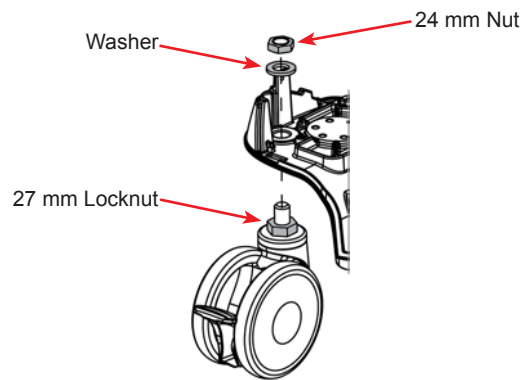
Figure 3-45 Caster Removal

- 40.1 Remove panels as necessary per Table 3-3 to gain access.
- 40.2 Lock casters opposite the caster to be removed.
- 40.3 Lift side with caster to be removed. and place a solid object under the chassis so that there is enough clearance above floor to remove the caster.
- 40.4 While holding the 27 mm locknut in place, remove the 24 mm nut and washer using a deep 24 mm socket wrench (see *Figure 3-45*).

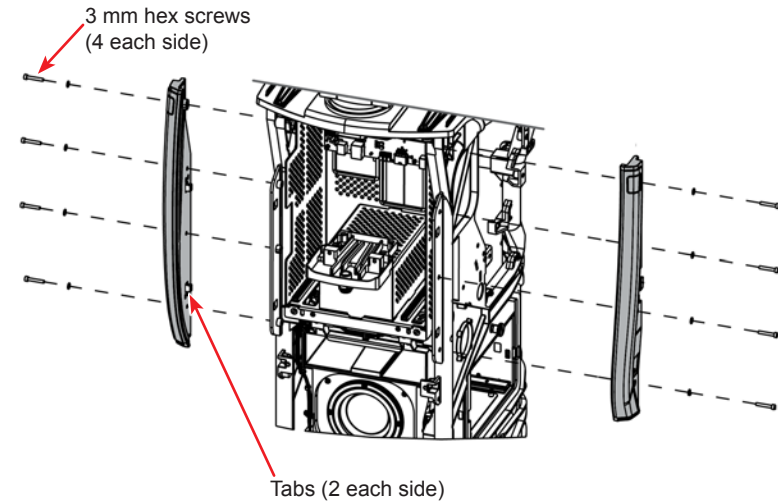
Figure 3-46 PEL Assembly Removal

- 41.1 Remove front and upper side panels (left or right as necessary for PEL Assembly to be replaced).
- 41.2 Disconnect cable from PEL PCB.
- 41.3 Remove four 3 mm hex screws and washers securing PEL Assembly to chassis (see *Figure 3-46*).

- 41.4 While holding the Display Insert Panel up for clearance, push PEL Assembly forward until it releases from tabs holding it to chassis.

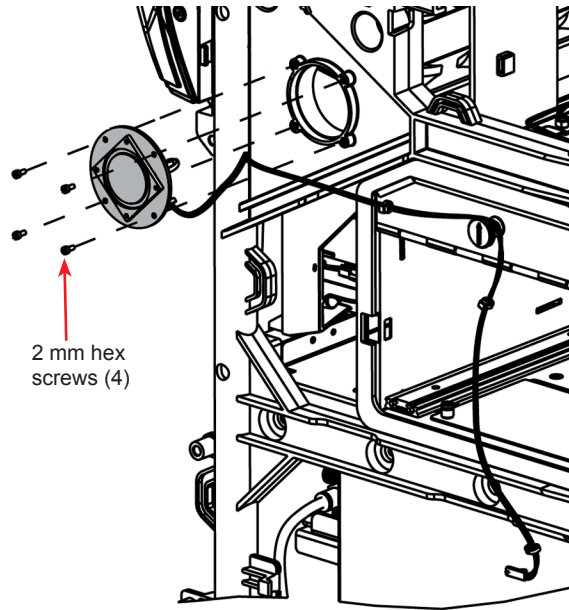
Figure 3-47 Side Speaker Removal

- 42.1 Remove upper and lower rear panels, and upper and lower side panels (left or right as appropriate for speaker to be removed).
- 42.2 Remove four 2 mm hex screws securing speaker/cable assembly to chassis (see *Figure 3-47*).

- 42.3 Disconnect connector from J28 (left) or J29 (right) on MFIO PCB.
- 42.4 Cut tie wraps as necessary and remove speaker/cable assembly from console.

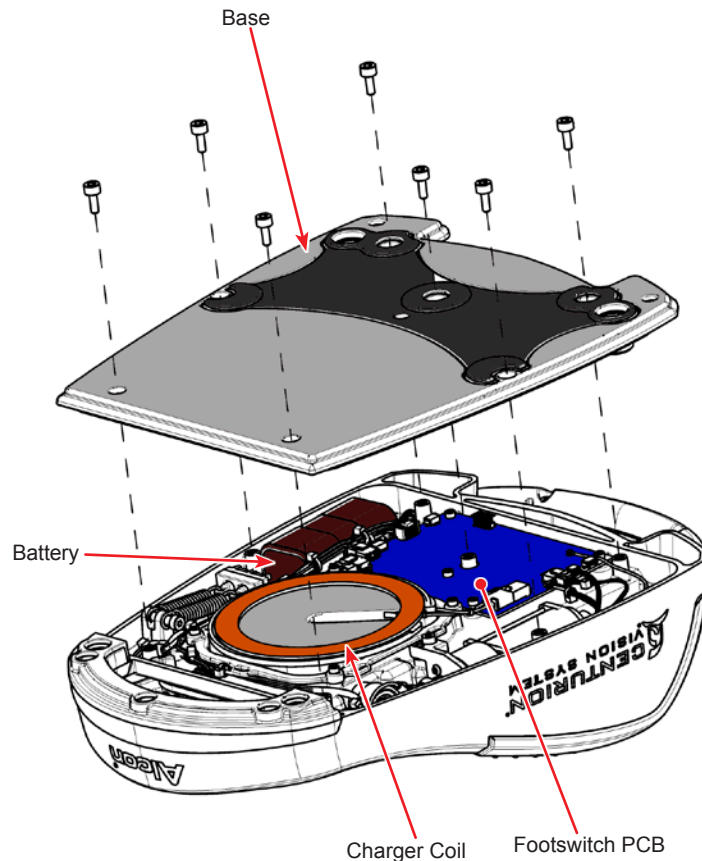
Figure 3-48 Footswitch Base Removal

- 43.1 Remove seven 4 mm hex screws securing Base to main housing (see *Figure 3-48*). Remove Base.
REPLACEMENT: Start all screws before tightening.
- 43.2 Disconnect Battery from J2 on Footswitch PCB. Remove Battery.

- 44.1 Remove seven 4 mm hex screws securing Base to main housing (see *Figure 3-48*). Remove Base.
REPLACEMENT: Start all screws before tightening.
- 44.2 Disconnect Charger Coil from J18 on Footswitch PCB. Remove Charger Coil.

- 45.1 Remove seven 4 mm hex screws securing Base to main housing (see *Figure 3-48*). Remove Base.
REPLACEMENT: Start all screws before tightening.
- 45.2 Remove Battery and Charger Coil as directed in previous steps. These items are not secured to the footswitch (connected to PCB) and will fall out when footswitch is turned over.
- 45.3 From underside of footswitch, remove one 2.5 mm hex screws securing each Cover to main housing (see *Figure 3-49*).
- 45.4 Turn footswitch over and remove three 2.5 mm hex screws securing Cover to main housing.
- 45.5 Remove Cover from footswitch, repositioning as necessary to slide it forward until it clears the footpedal. If removing the Right Cover, feed the connector plug assembly through the hole in the Cover prior to sliding it along the footpedal.

- 46.1 Remove seven 4 mm hex screws securing Base to main housing (see Figure 3-48). Remove Base.
REPLACEMENT: Start all screws before tightening.
- 46.2 Remove Battery and Charger Coil as directed in previous steps. These items are not secured to the footswitch (connected to PCB) and will fall out when footswitch is turned over.
- 46.3 Remove Right Wing Cover per step 45.
- 46.4 Note position of lanyard, then remove 2.5 mm hex screw securing Plug Assembly to chassis. Remove Plug assembly.

- 47.1 Remove seven 4 mm hex screws securing Base to main housing (see Figure 3-48). Remove Base.
REPLACEMENT: Start all screws before tightening.
- 47.2 Disconnect connectors from PCB at:
 - J2 -> W264 to Battery
 - J5 -> W260_1 & _2 to Left Switch
 - J6 -> W260_3 & _4 to Right Switch
 - J11 -> W266 to UP SWITCH PCB, LED PCB's
 - J12 -> W265 to Encoder
 - J13 -> W203 to Motor
 - J14 & J20 -> W267 to Console Connector
 - J18 -> W233 to Charger Coil
 - J21 -> W268 to Antenna
- 47.3 Remove five 2.5 mm hex screws securing Footswitch PCB to housing.
REPLACEMENT: Start all screws before tightening.
- 47.4 Remove Footswitch PCB from housing.

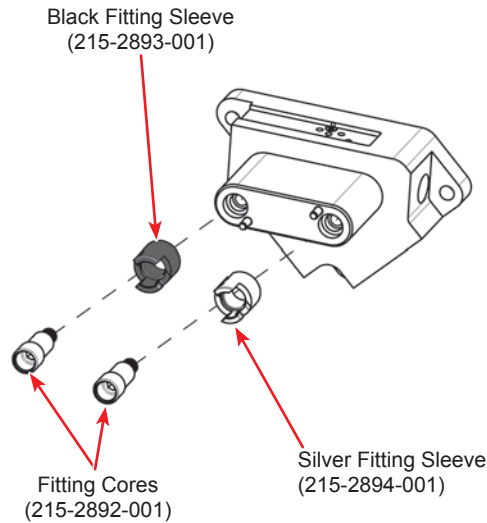
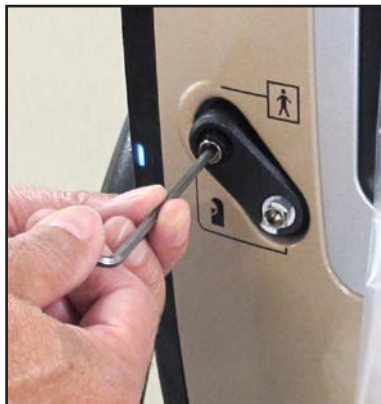
Figure 3-50 Pneumatic Fittings Removal

- 48.1 Using a 1/8 inch hex wrench, loosen the Pneumatic Fitting and remove from connector panel. Both the Fitting Core and Fitting Sleeve should come out.

REPLACEMENT: Ensure that Fitting Sleeve "cut-out" groove is properly fitted on the guide pin in the hole before tightening the Fitting in place.

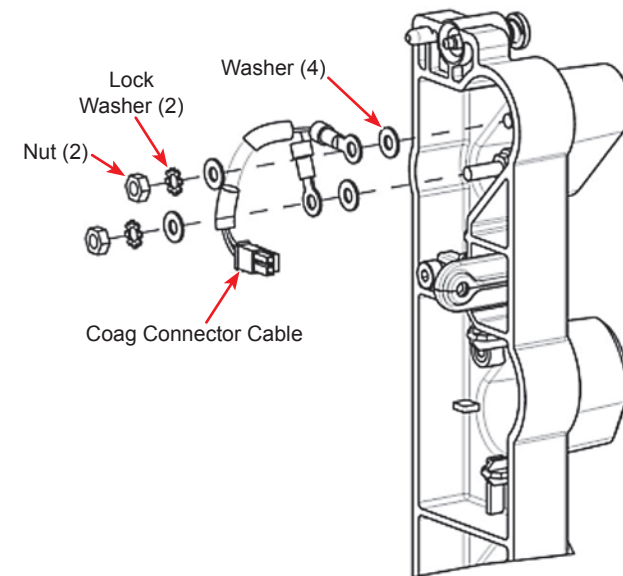
Figure 3-51 Removal of Coag Cable

- 49.1 Remove Fluidics Controller Assembly per step 17.
 49.2 Disconnect four connectors from the Fluidics Controller PCB: J10, J11, J14, and J15.
 49.3 Remove two 2 mm hex screws and two washers securing Fluidics Controller PCB to the connector panel.
 49.4 From the connector panel, remove nuts and washers securing Coag Connector Cable to two banana jacks (see *Figure 3-51*).

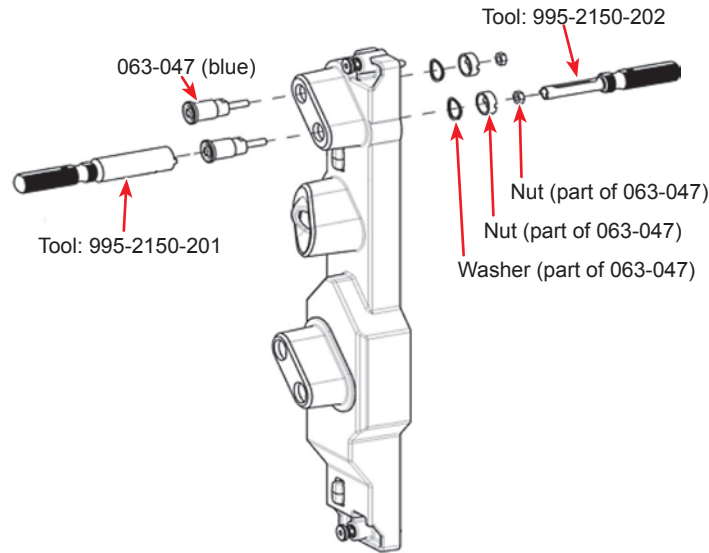
Figure 3-52 Coag Connectors Removal

- 49.5 Remove nuts and washers securing two banana jacks to panel housing using fixtures/tools 995-2150-201 and 995-2150-202 shown in *Figure 3-52*.

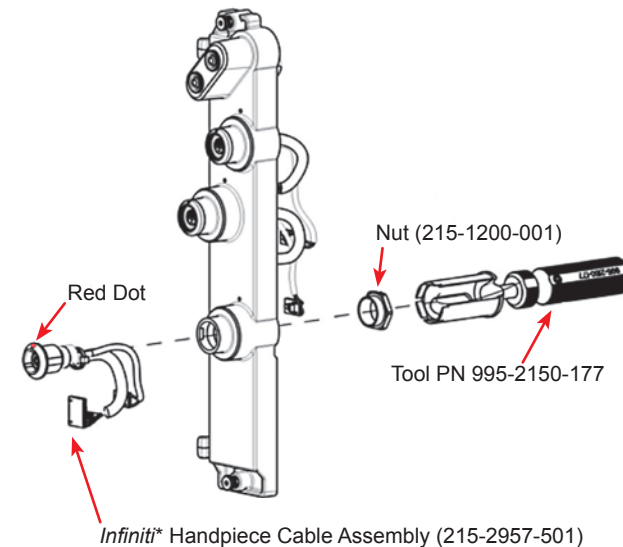
Figure 3-53 *Infiniti Handpiece Cable Assembly Removal**

- 50.1 Remove Ultrasonics (U/S) PCB Assembly per step 18.
- 50.2 Remove two 2 mm hex screws and washers securing Ultrasonics PCB to the assembly.
- 50.3 On the connector panel, remove nut securing Infiniti U/S Handpiece Cable Assembly (215-2957-501) using tool PN 995-2150-177 (see *Figure 3-53*). NOTE: Tool PN 995-2100-106 used on *Infiniti** systems also works for this connector.
- 50.4 Remove *Infiniti** U/S Handpiece Cable Assembly.

- 50.5 Remove and discard nut and washer from new *Infiniti** U/S Handpiece Cable Assembly.
- 50.6 Install the new *Infiniti** U/S Handpiece Cable Assembly into the connector panel and ensure the red dot of the cable is facing up as shown in *Figure 3-53*.
- 50.7 Secure cable assembly to connector panel with nut (215-1200-001) using tool 995-2150-177.

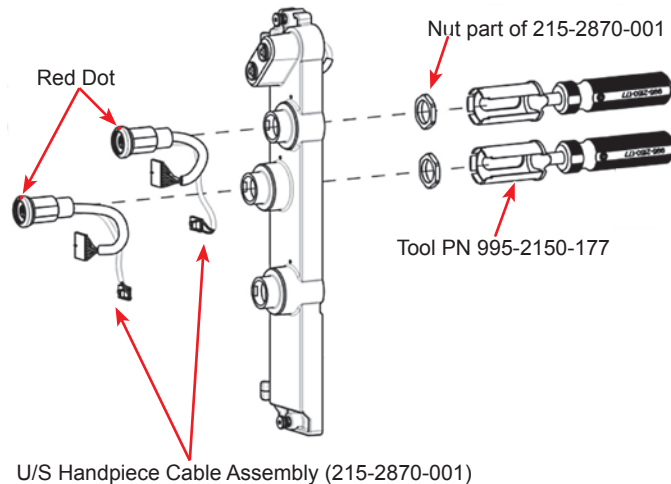
Figure 3-54 U/S Handpiece Cable Assembly Removal

- 51.1 Remove Ultrasonics (U/S) PCB Assembly per step 18.
- 51.2 Remove two 2 mm hex screws and washers securing Ultrasonics PCB to the assembly.
- 51.3 On the connector panel, remove nut securing U/S Handpiece Cable Assembly (215-2870-001) using tool PN 995-2150-177 (see *Figure 3-54*). NOTE: Tool PN 995-2100-106 used on *Infiniti** systems also works for this connector.
- 51.4 Remove U/S Handpiece Cable Assembly.

- 51.5 Remove nut from new U/S Handpiece Cable Assembly.
- 51.6 Install the new U/S Handpiece Cable Assembly into the connector panel and ensure the red dot of the cable is facing up as shown.
- 51.7 Secure cable assembly to connector panel with nut using tool PN 995-2150-177.

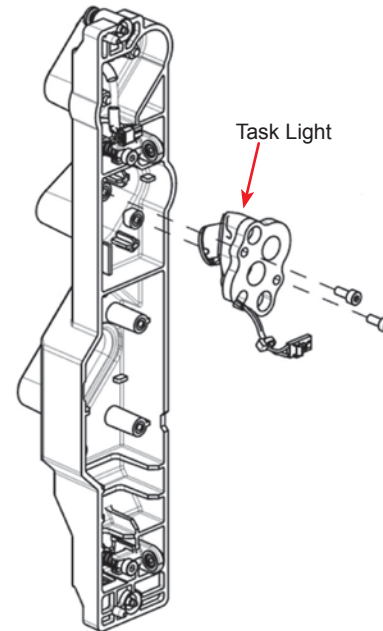
Figure 3-55 Task Light Removal

- 52.1 Remove Fluidics Controller Assembly per step 17.
- 52.2 Disconnect four connectors from the Fluidics Controller PCB: J10, J11, J14, and J15.
- 52.3 Remove two 2 mm hex screws and two washers securing Fluidics Controller PCB to the Connector Panel.
- 52.4 Remove two 3 mm hex screws securing Task Light Assembly to connector panel.
- 52.5 Remove Task Light Assembly.

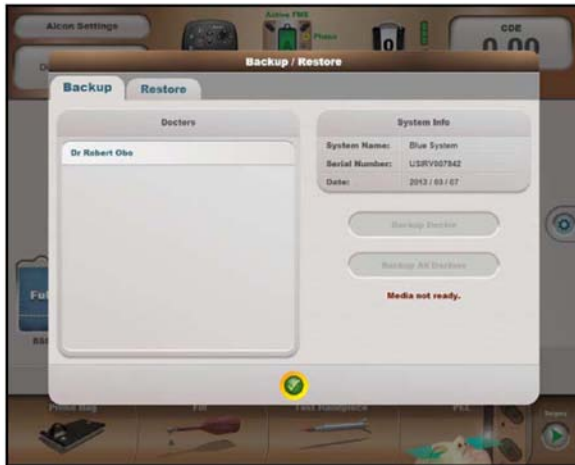
Figure 4-1 Backup/Restore Dialog Screen - Backup Tab

- 1.1.1 Plug a USB media into one of the rear I/O USB ports.
- 1.1.2 Select Backup/Restore from the Custom Menu. The Backup tab is the default as shown in *Figure 4-1*.
- 1.1.3 To backup an individual doctor: select *Doctor*, then press *Backup Doctor*.
- 1.1.4 To backup all Doctors: press *Backup All Doctors*.

- 1.2.1 Plug the USB media containing the Doctors Settings into one of the rear I/O USB ports.
- 1.2.2 Select Backup/Restore from the Custom Menu. The Backup tab is the default as shown in *Figure 4-1*.
- 1.2.3 Press the Restore Tab (see *Figure 4-2*).
- 1.2.4 To Restore an individual doctor:
 - 1.2.4.1 Press Doctors in the Sort By section.
 - 1.2.4.2 Press the Plus sign (+) next to the doctor's name.

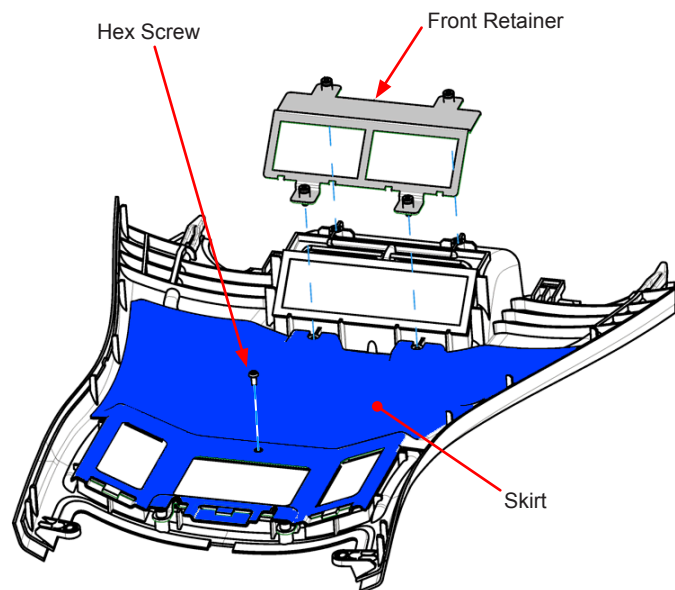
Figure 4-4 Lower Front Panel - Front Retainer and Skirt Removal

- 4.1 Remove the Lower Front Panel per Section Three of this manual.
- 4.2 Loosen four 3 mm captive screws securing the Front Retainer to the panel (see *Figure 4-4*). Remove Front Retainer and filter.

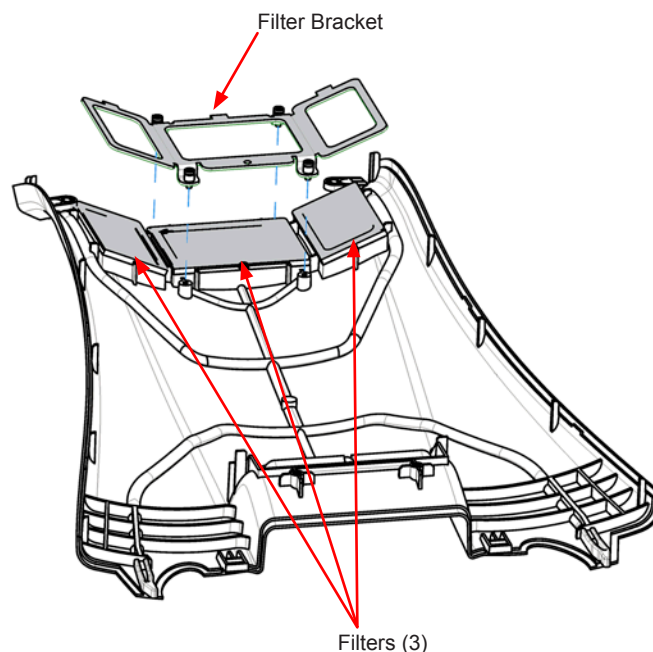
Figure 4-5 Lower Front Panel - Filter Bracket and Filter Removal

- 4.3 Remove 2.5 mm hex screw securing Skirt to Panel. Remove Skirt from Panel.
- 4.4 Loosen four 3 mm captive screws securing Filter Bracket to panel (see *Figure 4-5*). Remove Filter Bracket and three filters.

- 4.5 Clean four filters with water then shake dry.
- 4.6 Reassemble Front Panel assembly by performing this procedure in reverse order.

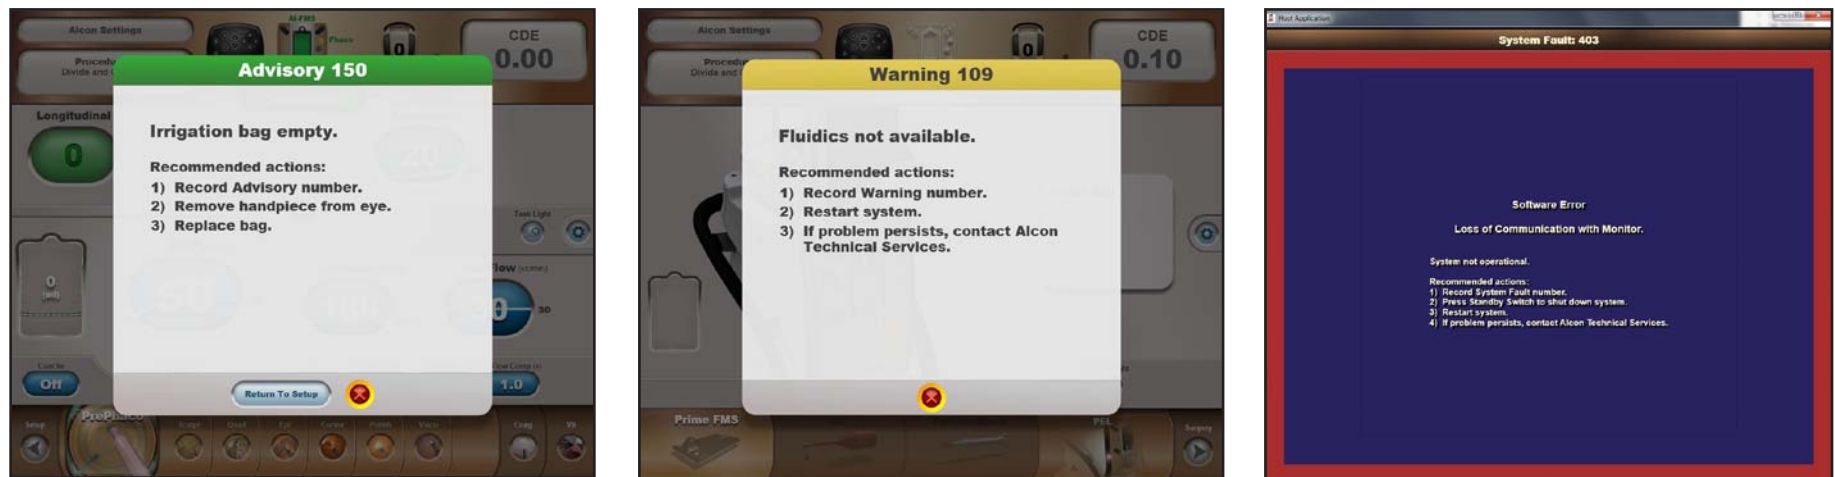
Figure 4-6 Advisory, Warning, and Fault Screen Examples

Figure 4-6 shows an example of each.

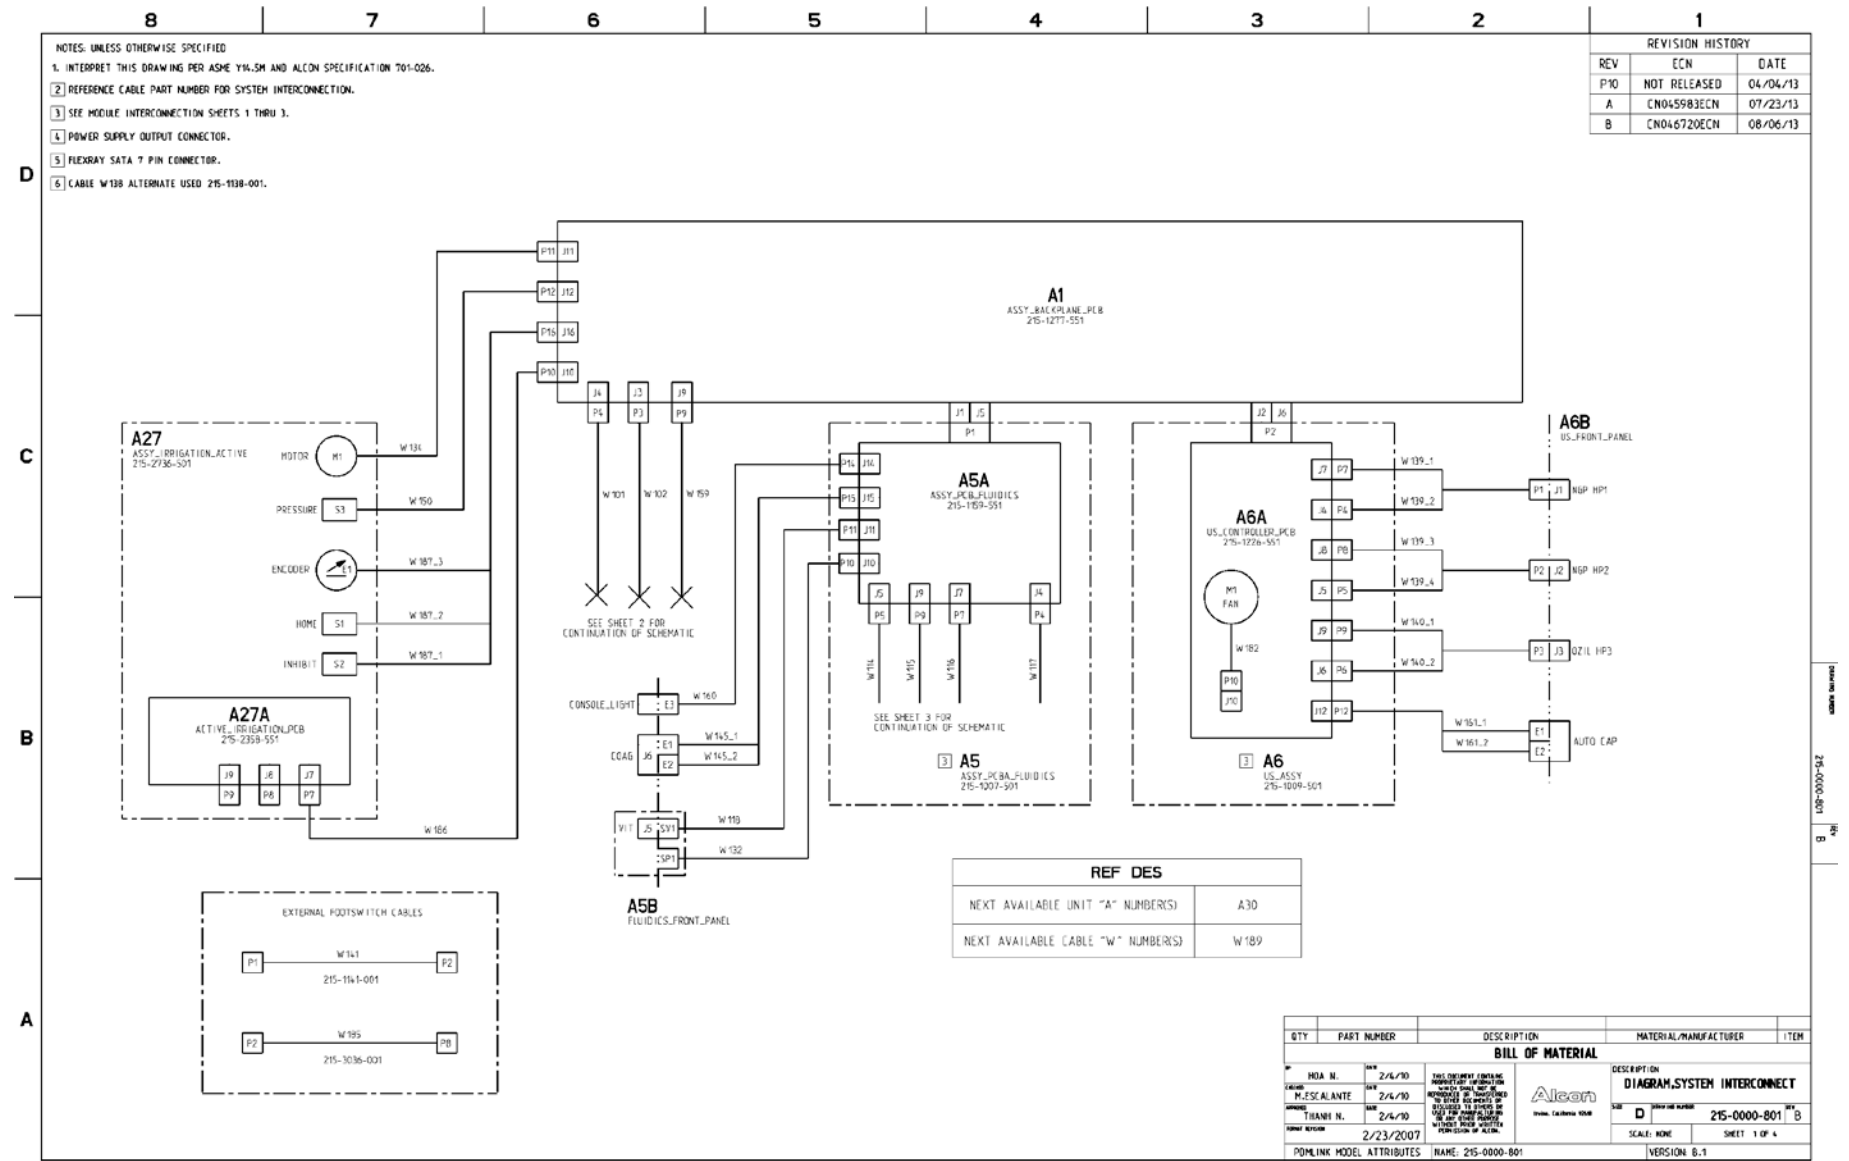
Figure 5-1 System Interconnect Diagram (sheet 1 of 4)

Figure 5-1 shows the system interconnect diagram for the *Centurion** console.

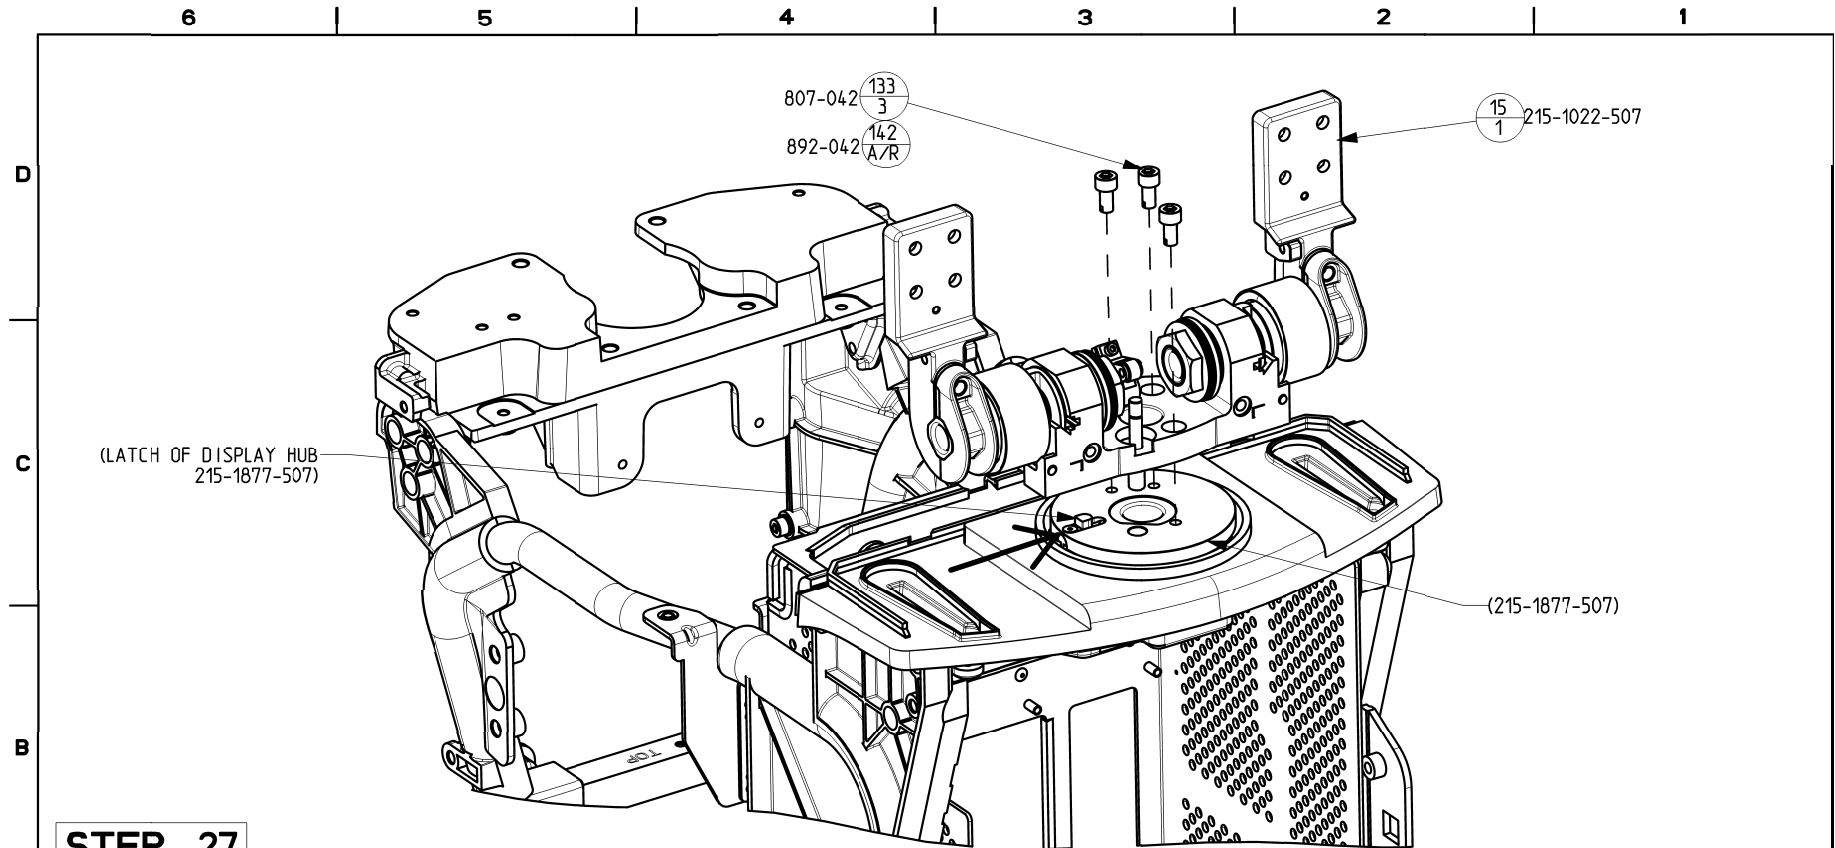
STEP 27

1. ENSURE DISPLAY HINGE 215-1022-507 SERIAL NUMBER MATCHES CONSOLE SERIAL NUMBER. STAMP DHR DATA SHEET TO CONFIRM DISPLAY HINGE SERIAL NUMBER MATCHES CONSOLE SERIAL NUMBER.
2. PRESS AND HOLD IDENTIFIED LATCH OF DISPLAY HUB 215-1877-507 TO THE RIGHT.
3. PLACE DISPLAY HINGE 215-1022-507 ONTO DISPLAY HUB 215-1877-507.
- A 4. ADD LOCTITE 892-042 TO 3X SCREWS 807-042.
5. SECURE DISPLAY HINGE 215-1022-507 TO HUB 215-1877-507 WITH 3X SCREWS 807-042.
6. INSERT DISPLAY HINGE / DISPLAY HUB DHR DATA SHEET INTO THE OVERALL CONSOLE DHR PACKET. ENSURE SERIAL NUMBERS OF BOTH DATA SHEETS MATCH BEFORE PROCEEDING. STAMP DHR DATA SHEET TO CONFIRM DISPLAY ARM ASSEMBLY DHR DATA SHEET HAS BEEN INSERTED INTO CONSOLE DHR PACKET.

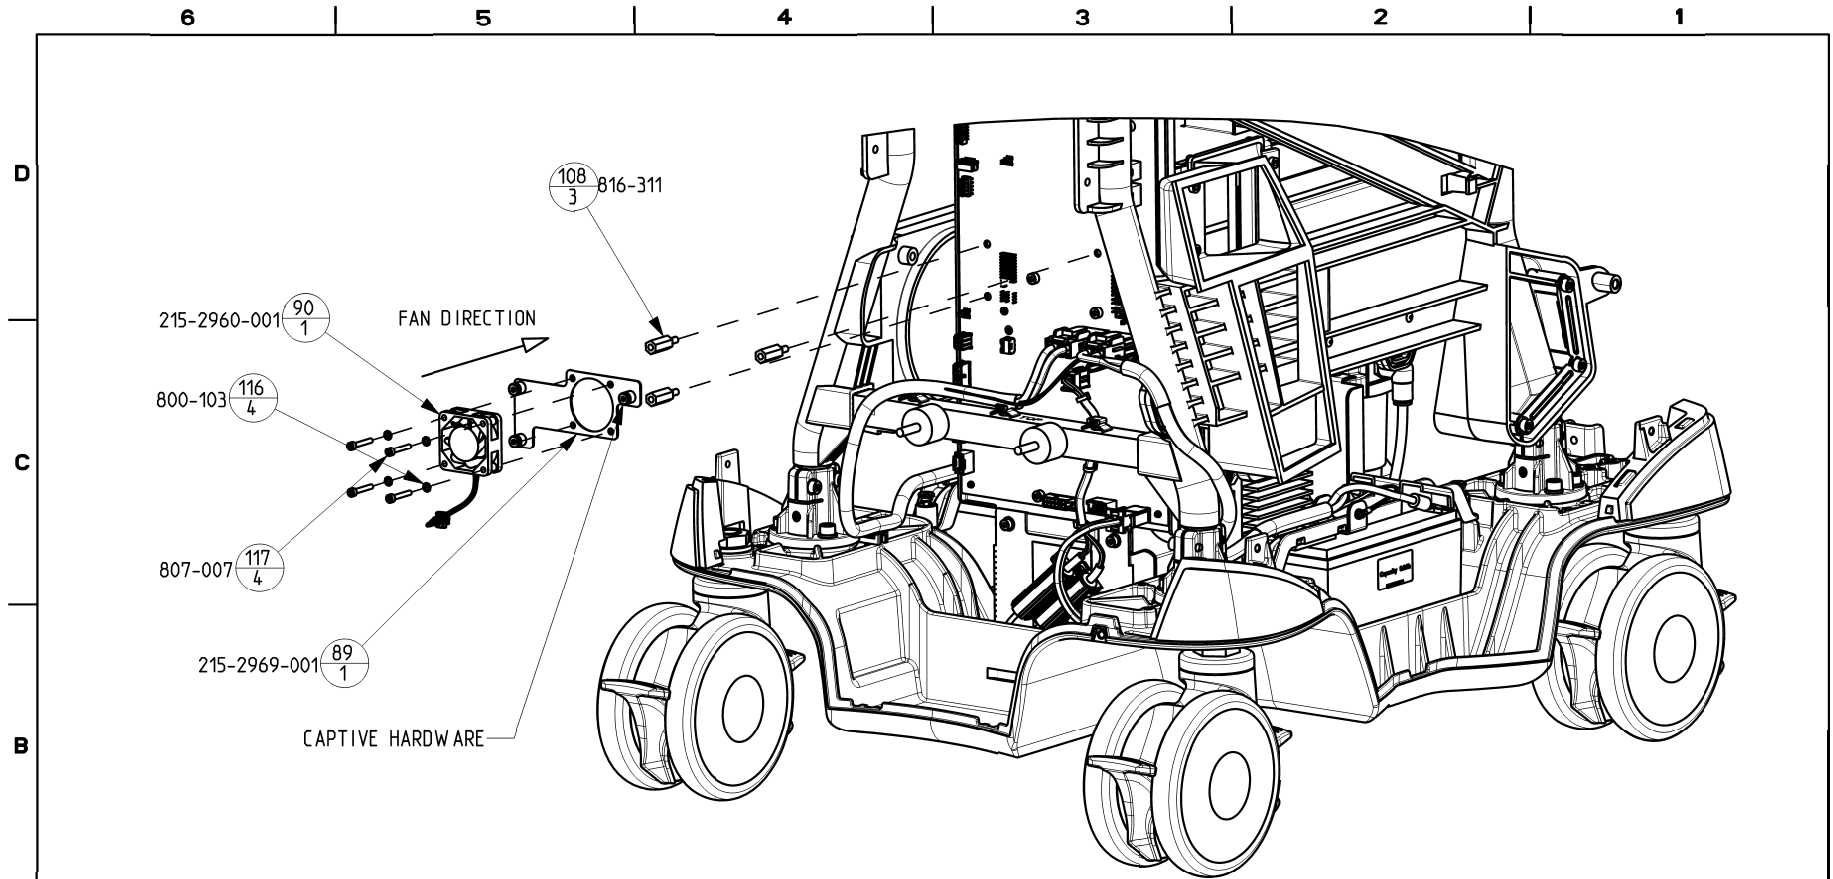
STEP 30

1. INSTALL 3X STANDOFFS 816-311 ONTO CHASSIS 215-1004-001 IN LOCATIONS SHOWN.
2. INSTALL BRACKET 215-2969-001 ONTO 3X STANDOFFS WITH 3X CAPTIVE HARDWARE.
3. INSTALL FAN 215-2960-001 ONTO BRACKET 215-2969-001 IN ORIENTATION SHOWN (FAN DIRECTION FACES IN, AND FAN CABLE FACES DOWN) WITH 4X WASHERS 800-103 AND 4X SCREWS 807-007.

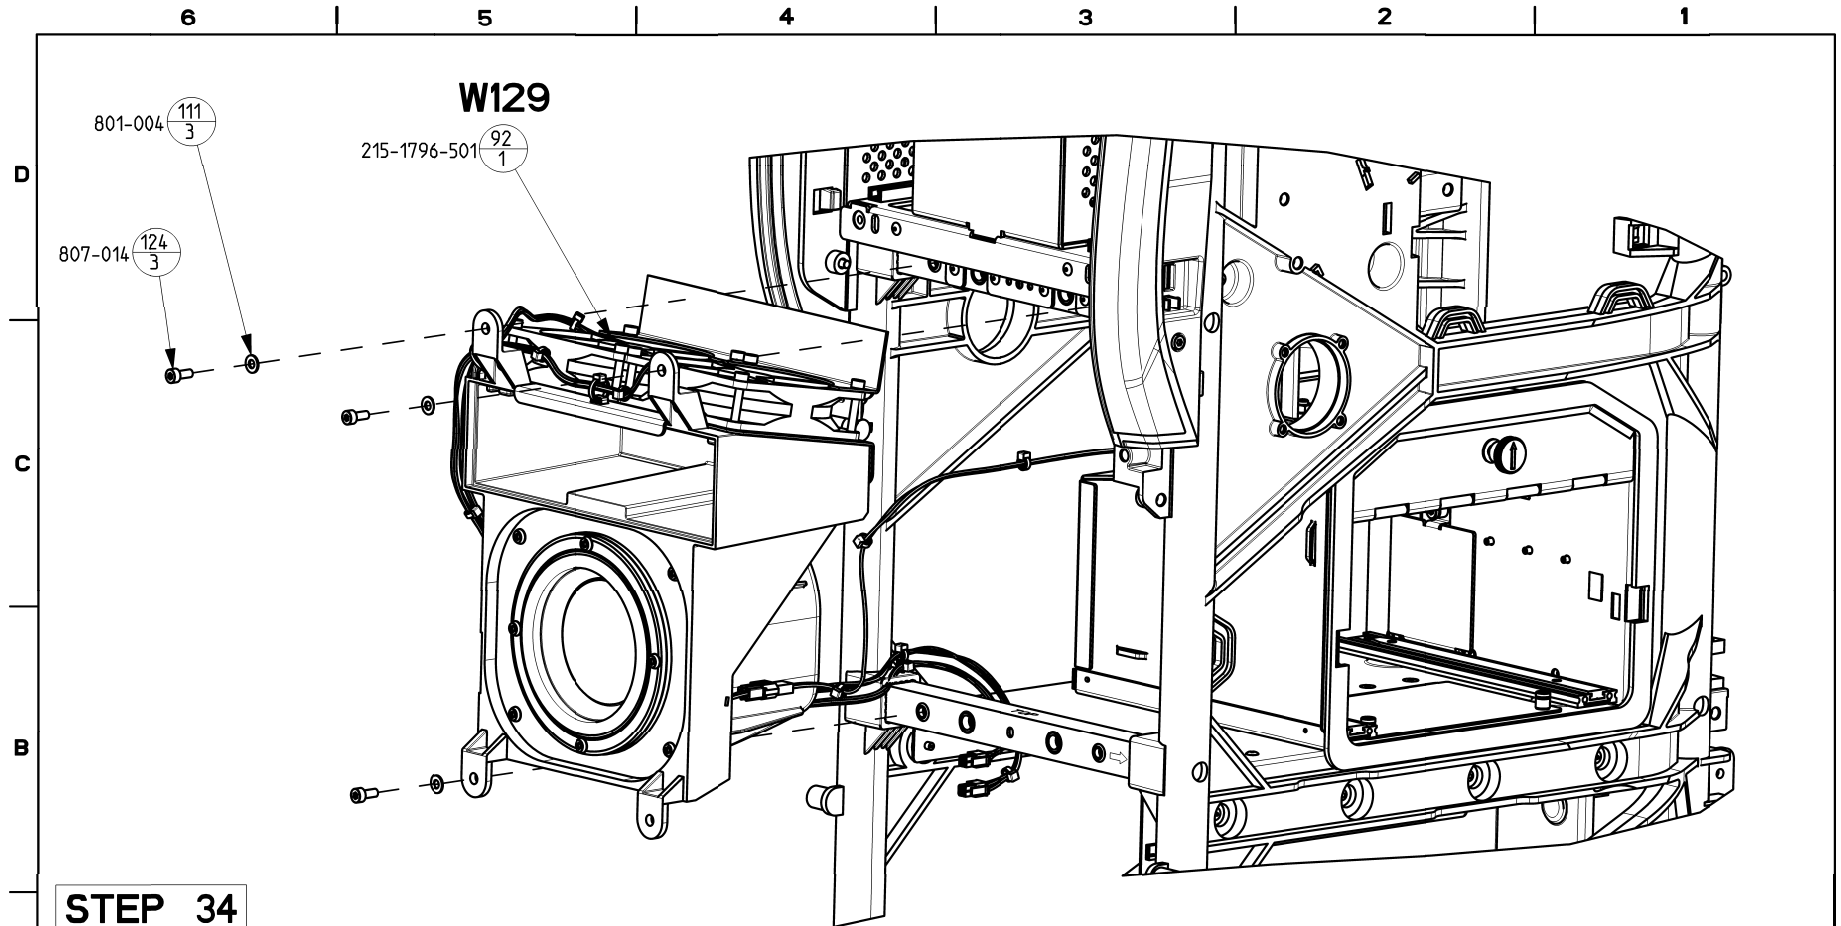
STEP 34

1. CONFIRM SERIAL NUMBER OF FILTER BOX 215-1796-501 MATCHES SERIAL NUMBER OF CONSOLE.
STAMP DHR DATA SHEET TO CONFIRM FILTER BOX SERIAL NUMBER MATCHES CONSOLE SERIAL NUMBER.
2. INSERT FILTER BOX 215-1796-501 DHR DATA SHEET INTO OVERALL CONSOLE DHR PACKET.
STAMP DHR DATA SHEET TO CONFIRM FILTER BOX DHR DATA SHEET HAS BEEN INSERTED INTO CONSOLE DHR PACKET.
3. INSTALL FILTER BOX ASSEMBLY 215-1796-501 ONTO CHASSIS 215-1004-001 WITH 3X WASHERS 801-004 AND 3X SCREWS 807-014.
4. ROUTE FILTER BOX FAN CABLES (2X W129) THRU CONSOLE AND CONNECT TO MFIO PER CABLE ROUTING FILE 215-0000-501_PROC_CABLE.ASM, "W129".

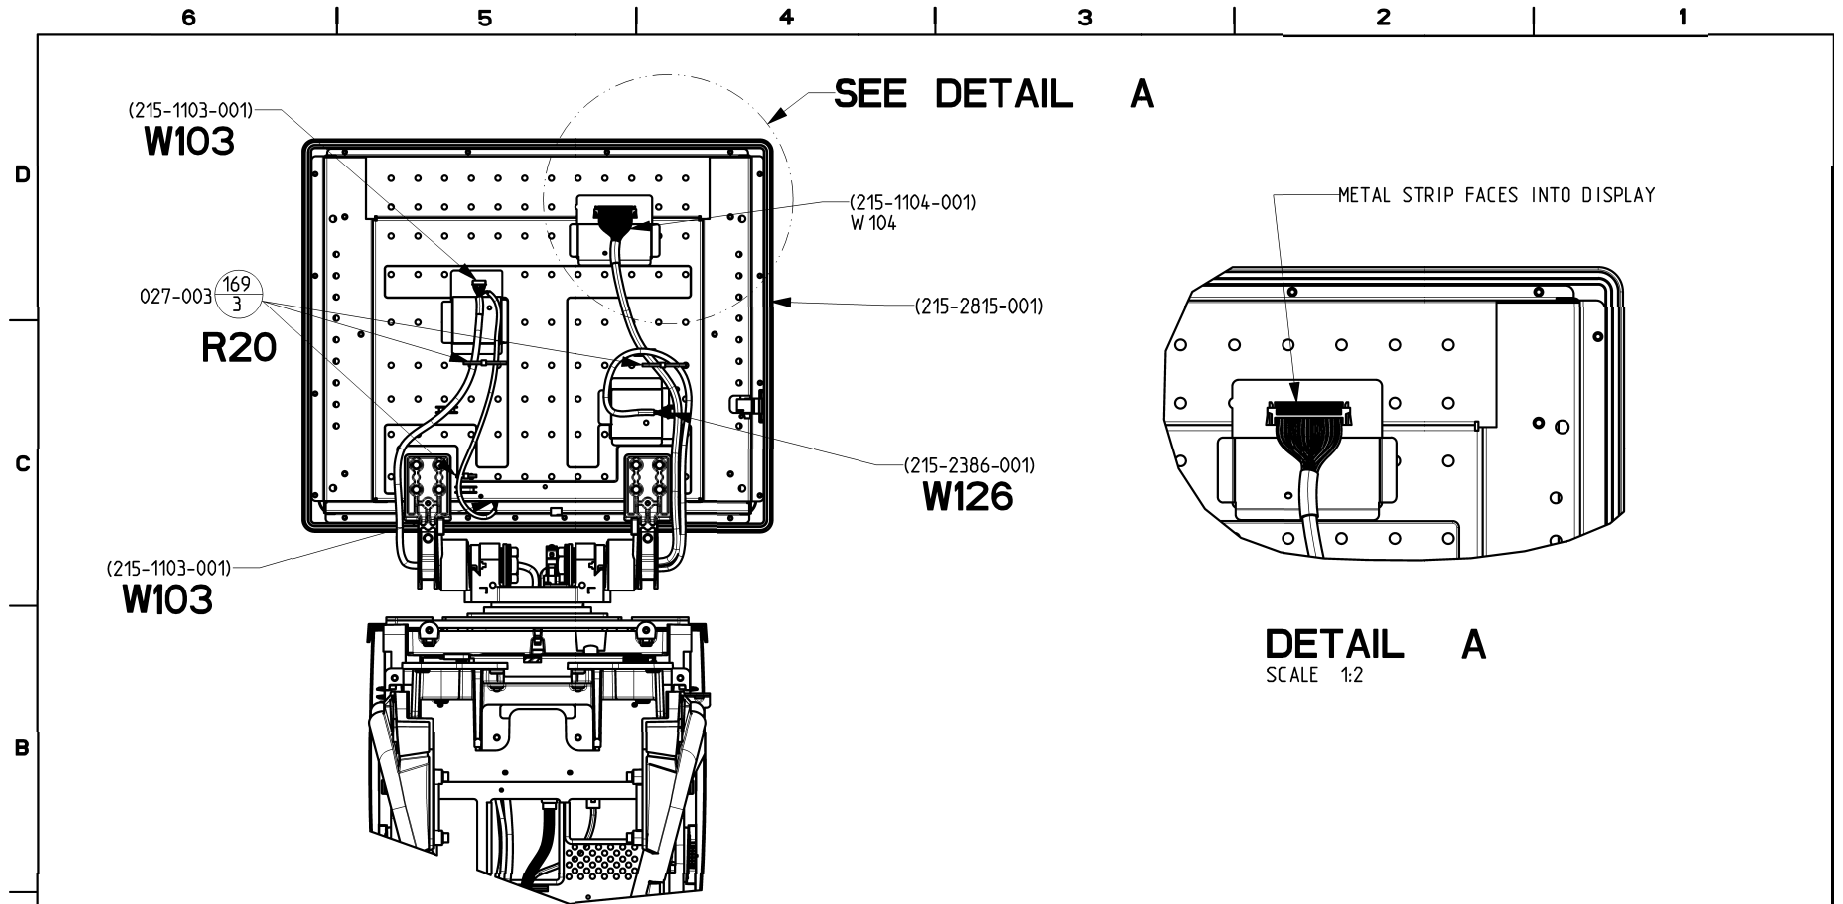
SIZE B	DRAWING NUMBER 215-0000-501	REV K
SCALE: 1:4	SHEET 62 OF 138

DETAIL A
SCALE 1:2

STEP 61

1. CONNECT CABLES 215-1103-001 (W103), 215-1104-001 (W104) AND 215-2386-001 (W126) TO IDENTIFIED LOCATIONS OF DISPLAY 215-2815-001, REFERENCE FILE 215-0000-501_PROC_CABLE.ASM FOR DETAILS.
2. HARNESS CABLES ABOVE TO DISPLAY WITH 3X TIE WRAPS 027-003. TRIM EXCESS TIE WRAP. REFERENCE 215-0000-501_PROC_CABLE "R20" FOR DETAILS.
